Position of Underlayment to Prevent Cracked Tile and Grout

Frank Woeste, P.E.

*Peter Nielsen,
Schluter Systems L.P.*

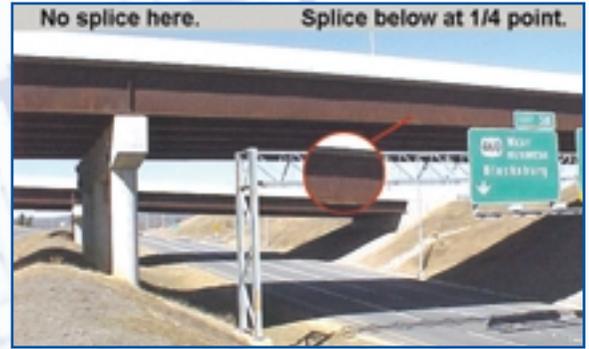
Figure 2. A two-span highway bridge is shown. Note, though difficult to see in the photo, the splice in the steel beam is placed to the left of the Blacksburg sign, and not at the center concrete pier support. The dark line above concrete support is not a splice, but rather a web stiffener. Engineers splice their multi-span beams near the 1/4-points of spans where the bending stress is low. By analogy, it is logical to butt underlayment near the 1/4-points of the sheathing span between the floor joists.

Figure 2 shows a two-span highway bridge near Blacksburg, VA (This beam is analogous to a half sheet of plywood on joists at 24" o.c.). Note that the beam is not spliced over the center support, but, rather, that it is spliced at the 1/4-point of the right span to the left of the Blacksburg sign (The dark line in Figure 2 above the pier support is a web stiffener, not a splice). If a two-span beam is spliced, it will generally be spliced near the 1/4-point of the span. Knowing that a splice is the weak point of a beam, why would highway engineers make the splice near the 1/4-point? The answer lies in the bending stress diagram under various loading conditions. As vehicles pass across the bridge, the stress diagram changes much like the stress that might be produced by a heavily loaded dolly in a house. In general, the stress at the center support is the highest where the curvature is maximum. At about the 1/4-point of the span, the stress is much lower relative to the center support location. Near the center of the right span, the stress and correspon-

ding curvature increases again. The next time you drive past a 2-span or 3-span bridge, notice where the splices are: at the 1/4-points, not over the piers.
